Arkansas River Ranch Trail Phase I Construction Layout As Built Photo Plates and Figures

**Prepared for:
Arkansas Headwaters Recreation Area
Colorado Parks and Wildlife
307 W. Sackett Ave.
Salida, Colorado
81201**

December, 2012

**Arkansas River Ranch Trail
Phase I Construction Layout
As-Built Illustrations**

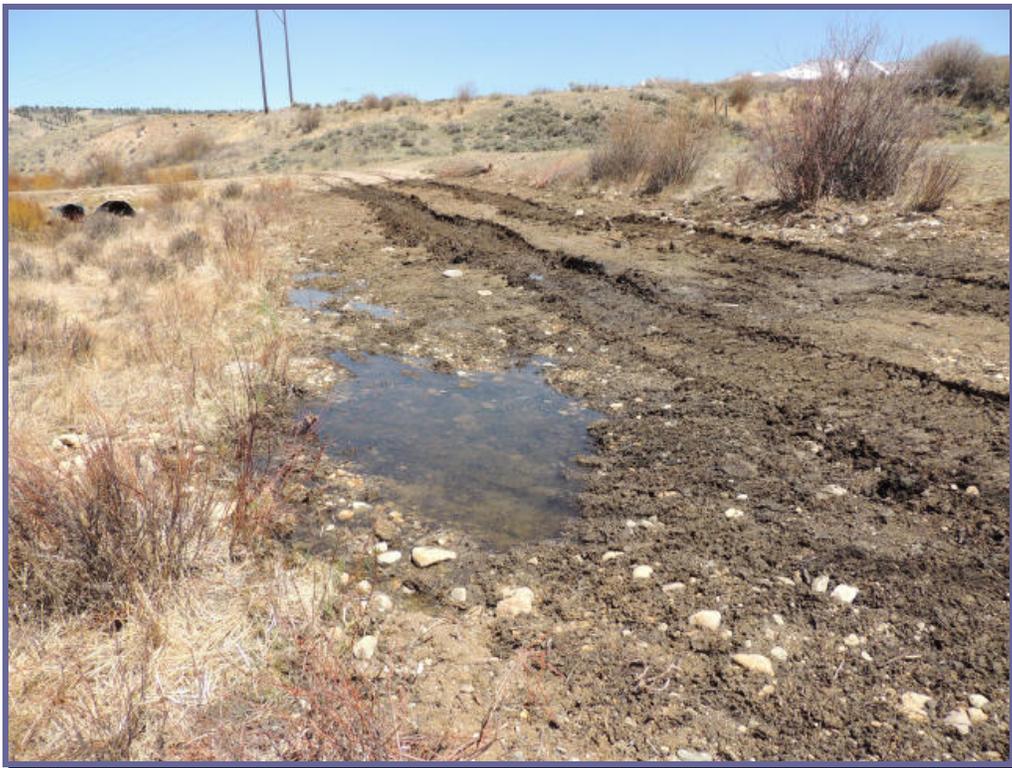
Photo Plate 1 illustrates the pre-construction condition of the transition zone with standing water and a muddy, heavily rutted travel surface, incapable of supporting sustainable trail development. Photo Plates 2 and 3 illustrate the proposed realignment of the trail onto upland soils to circumvent the seep area and the short transition through wetland soils to re-connect the trail alignment to the existing EPA Haul Road. Plates 2 and 3 were taken prior to the start of construction. The construction of the trail base through the transition zone impacts a riparian area that was not disturbed under the EPA's Nation Wide Permit 38, and is subject to the CPW Nation Wide Permit 42.

Before: Area of Avoidance 1 - Station 23+60 to 27+20. Winter excavation stripped away the entire soil bridge, including fabric, cobble, fines and traction rock layers, and resulted in the interception of ground water from a perched pond on the hillside above, making the section of the trail corridor impassible for vehicular or bicycle/pedestrian travel.

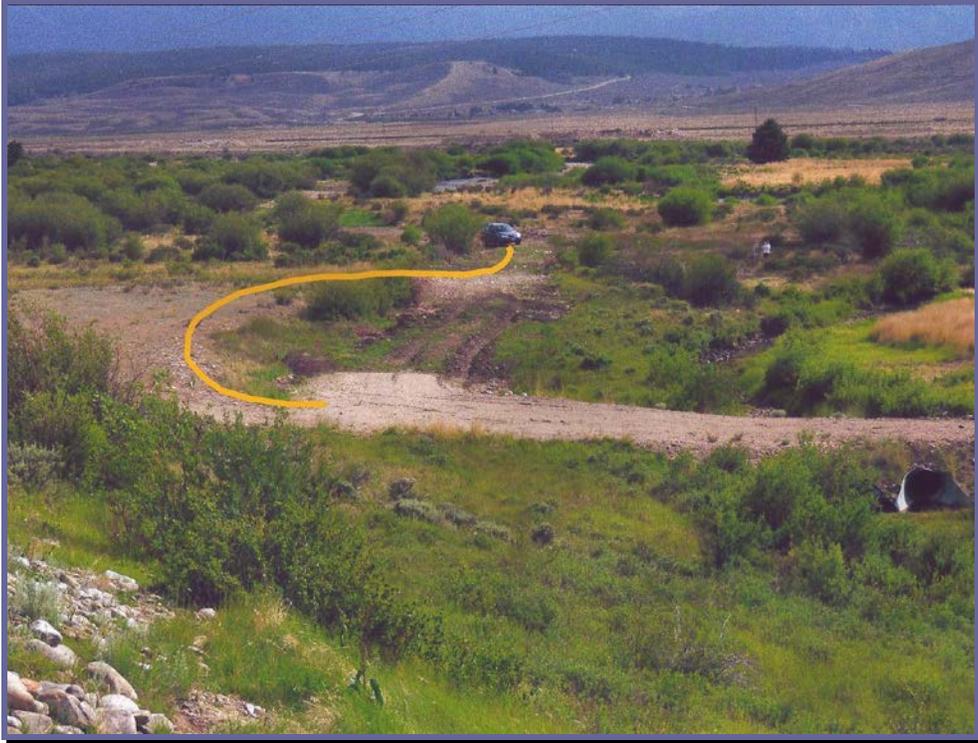
Plan: The Phase I Construction Layout called for bypassing the area of constraint by re-routing the trail to upland soils south of the seep area, and transitioning through a short section of riparian area to connect to the stable section of the EPA haul road.

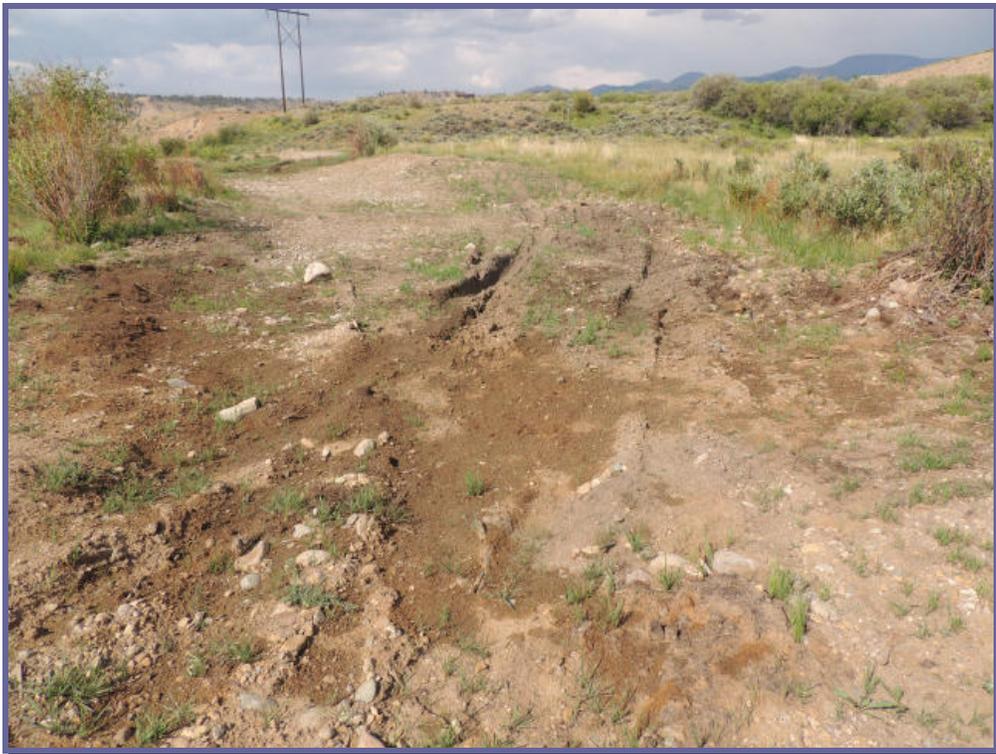
Photo Plate 3

Before: “Transition” area between upland soils (upper half of photo) and stable road section (Photographer’s location), crossing through a riparian area for a distance of approximately 110 feet.

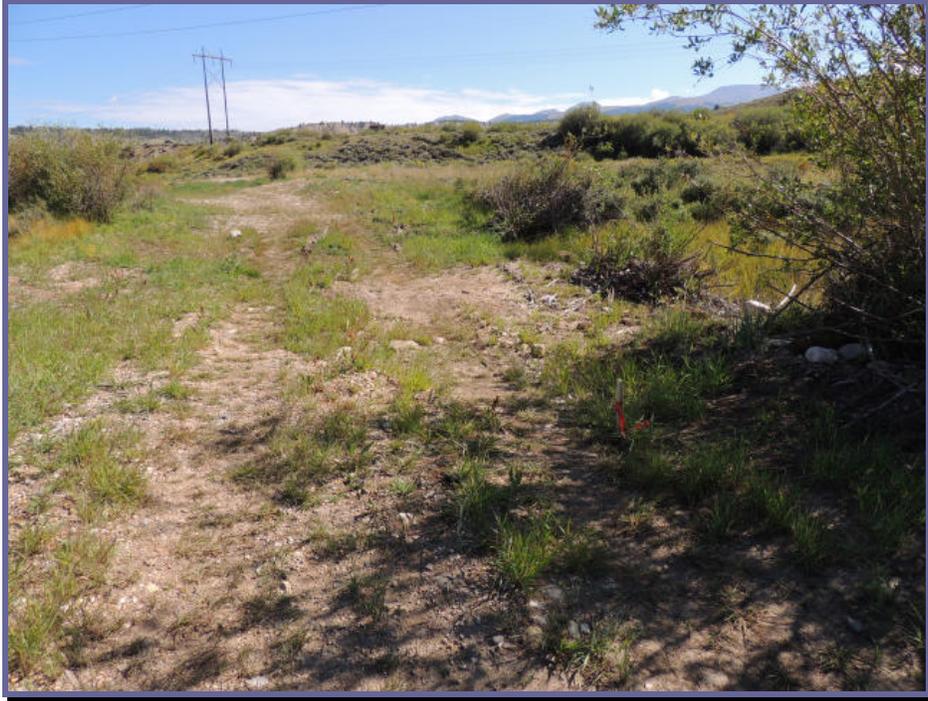
Before: Station 23+50 looking east through the wetland transition area to the upland soils. Area of wetland disturbance is approximately 110 feet in length, and is covered under a CPW Nationwide 42 Permit from the Army Corps of Engineers.

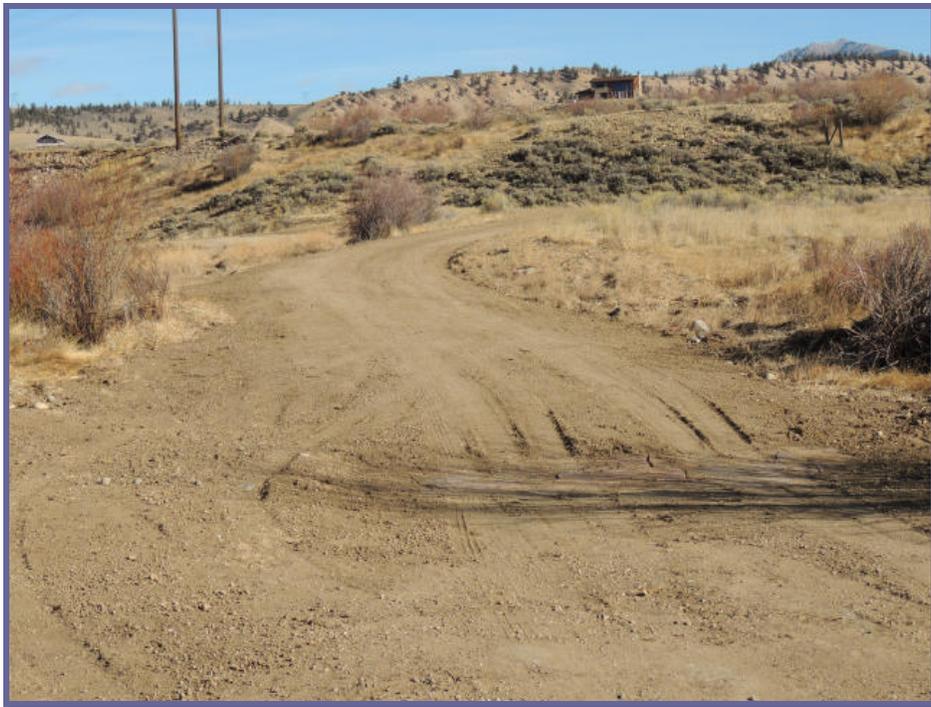
Photo Plat 5

As Built: Completed bypass around seep area including reconstruction of the soil bridge over a riparian area and installation of a Low Flow Crossing at the low point at base of transition to allow cross flow of flood waters between the river and the surrounding floodplain.

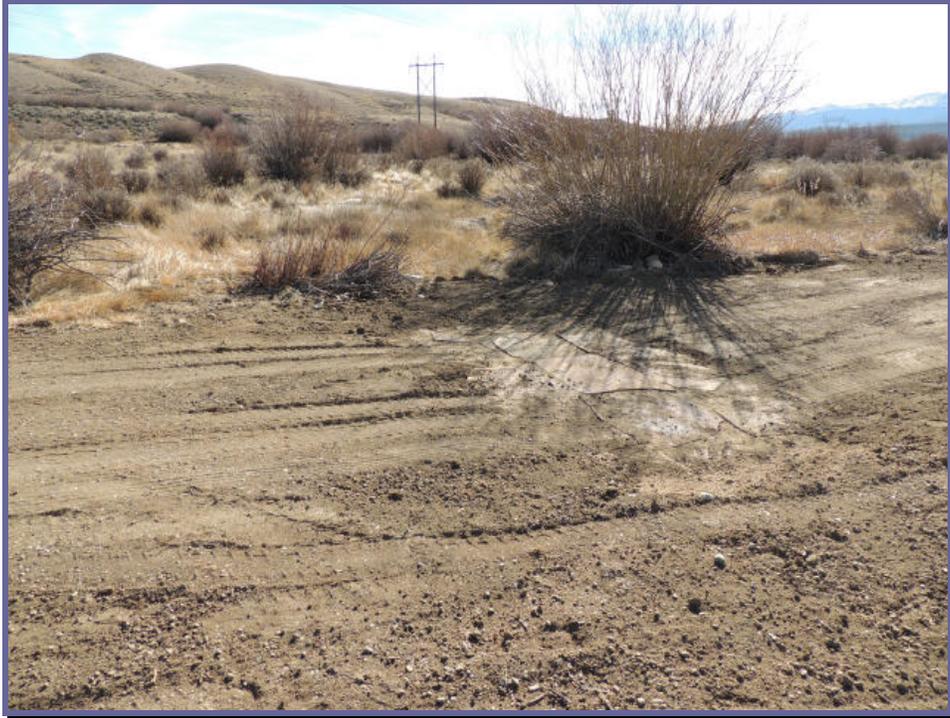
As Built: Low Flow Crossing #5, Station 23+60 at the base of the transition to support emergency and maintenance vehicle passage, and accommodate bicycle/pedestrian traffic on a hard surfaced, shallow water crossing during high flow events.

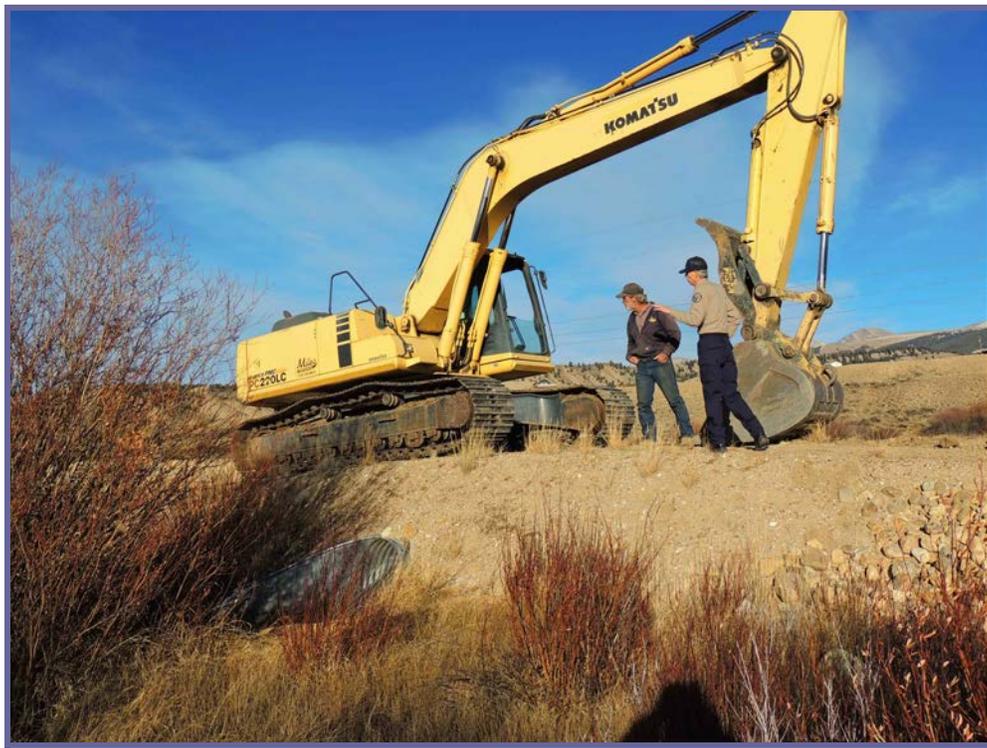
Photo Plate 7

As Built: Preparing to remove Culvert # 1, Station 33+35.

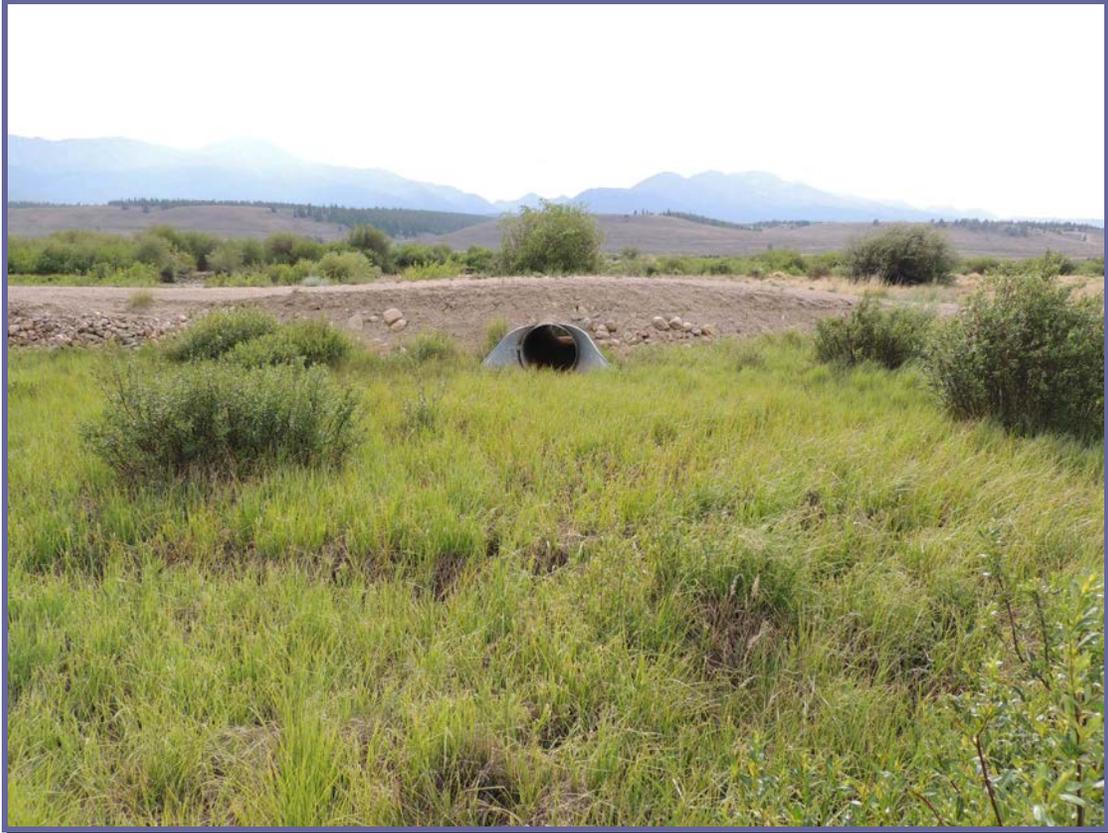
Before: Station 33+37 - Culvert 1 prior to removal: 30” culvert with 2’ of cover material.

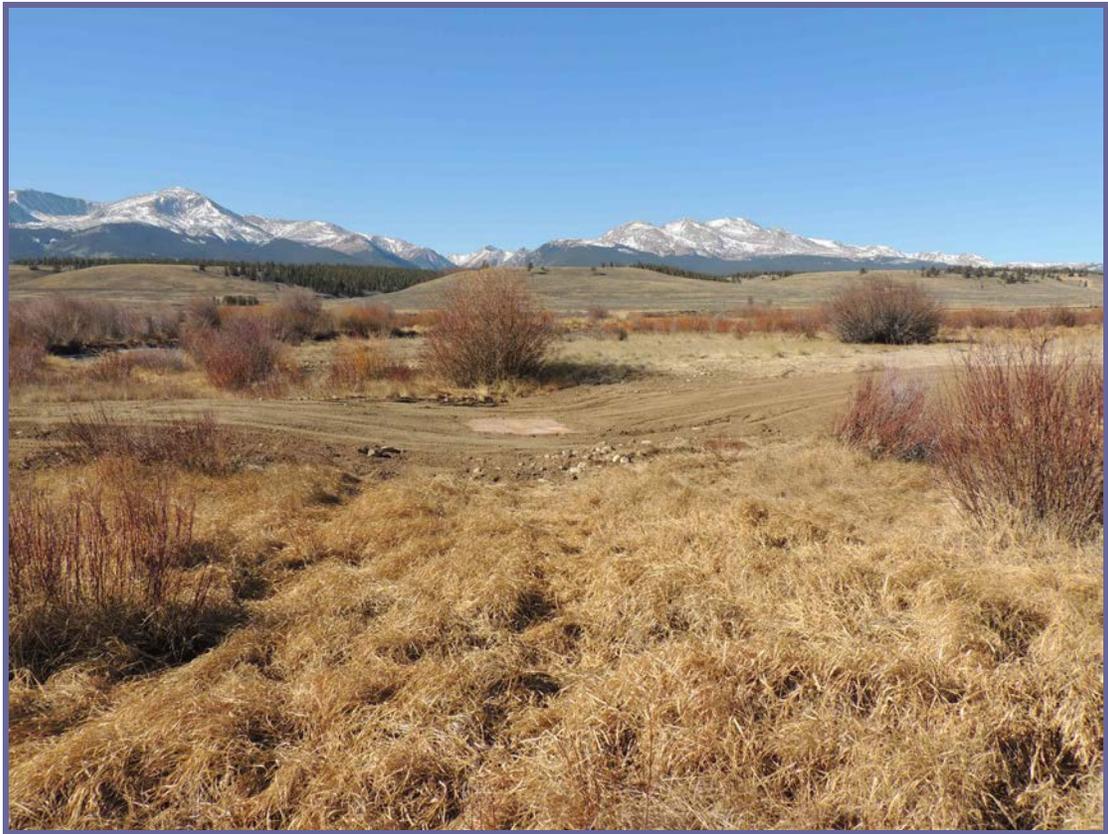
As Built: Station 33+37- After removal of culvert and replacement with Low Flow Crossing.

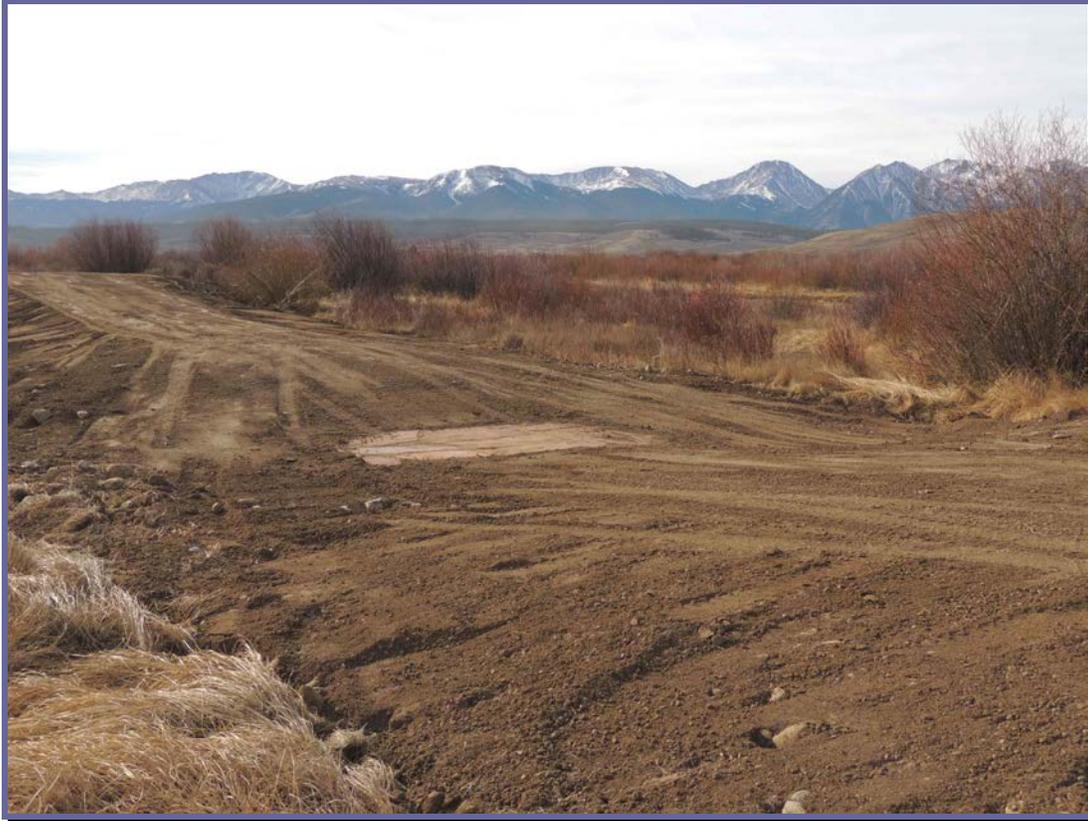
As Built: Culvert # 1 removed and replaced with a Low Flow Crossing.

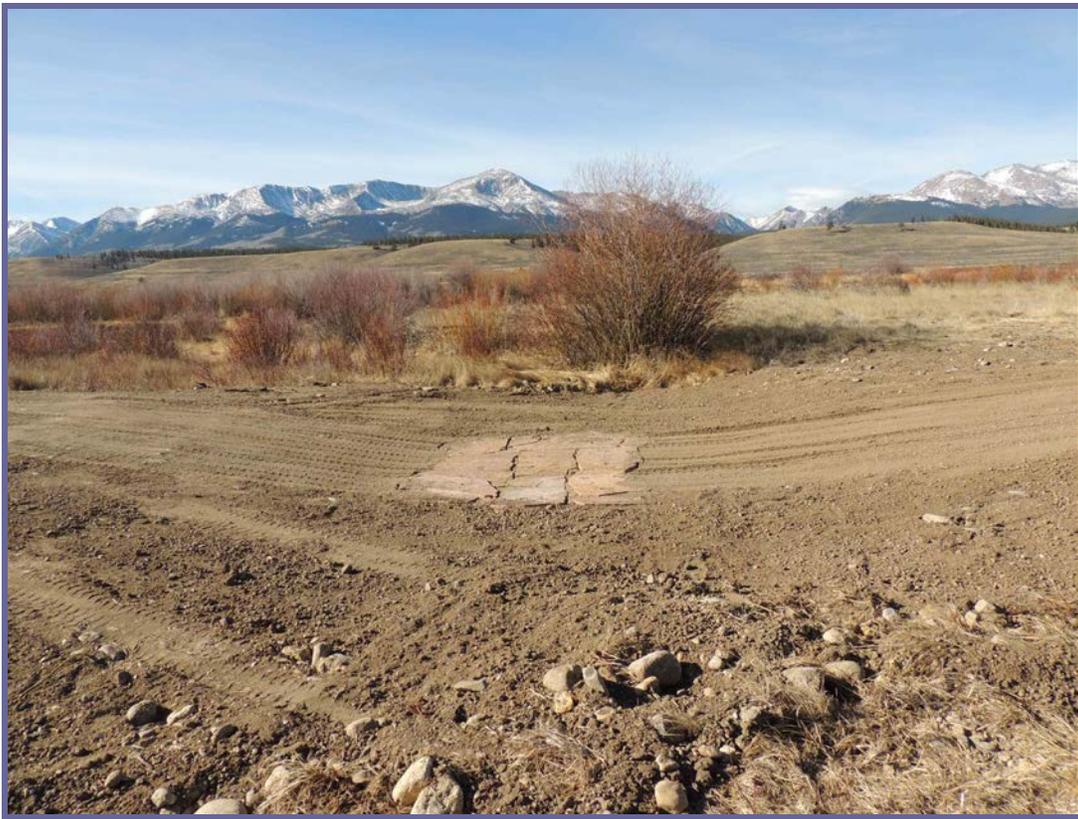
Photo Plate 11

As Built: Low flow crossing in place of Culvert # 1.

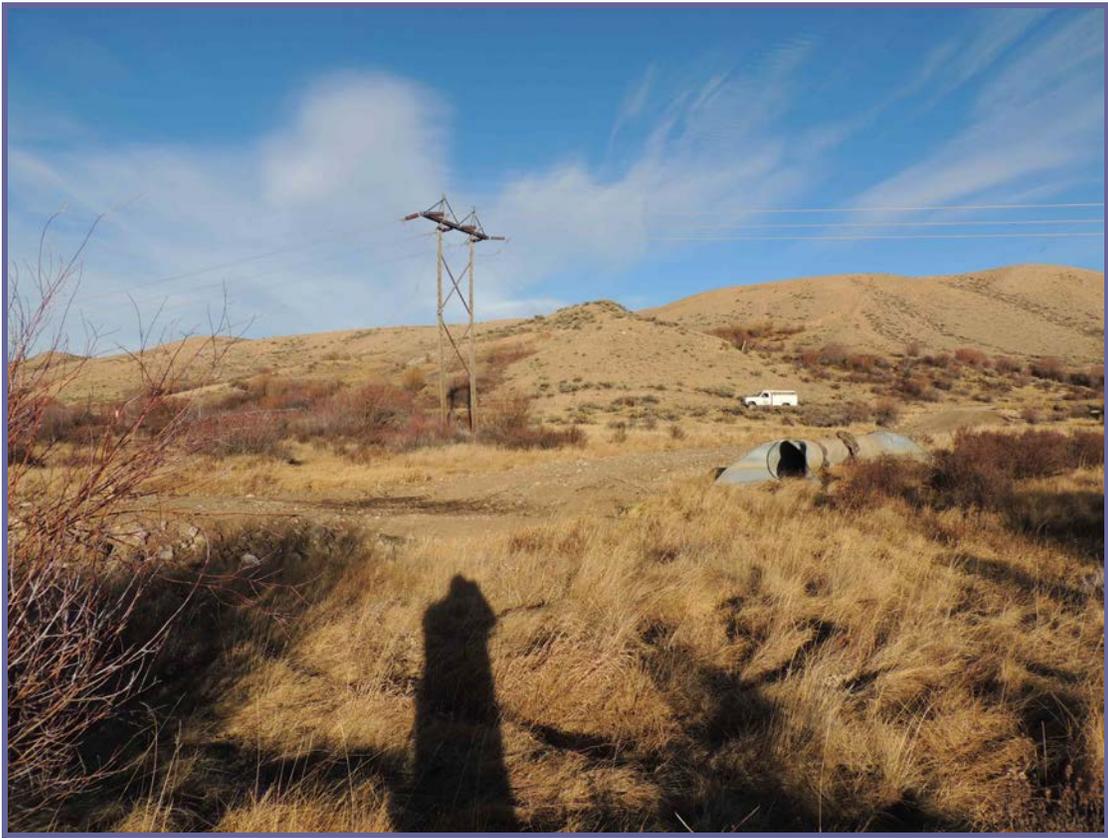
Photo Plate 12

As Built: Station 2+23 - Removal of Culvert # 6.

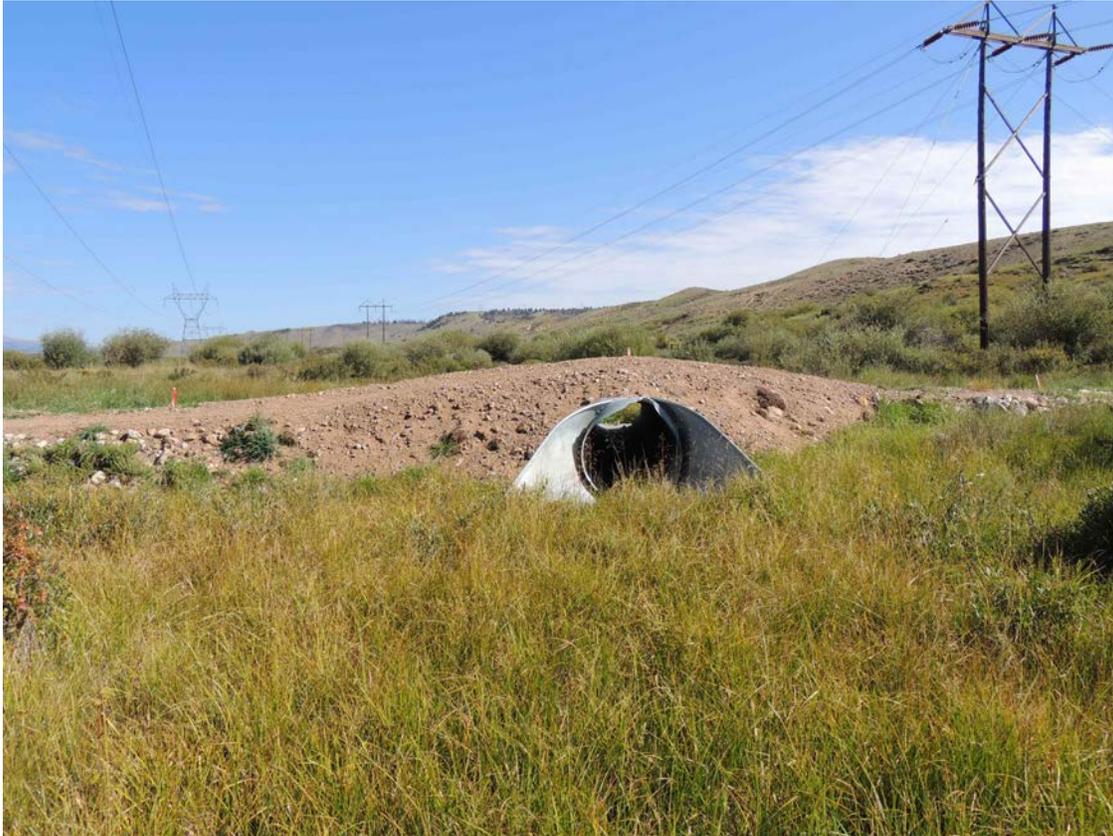
Before: Station 2+23, Culvert #6 prior to removal.

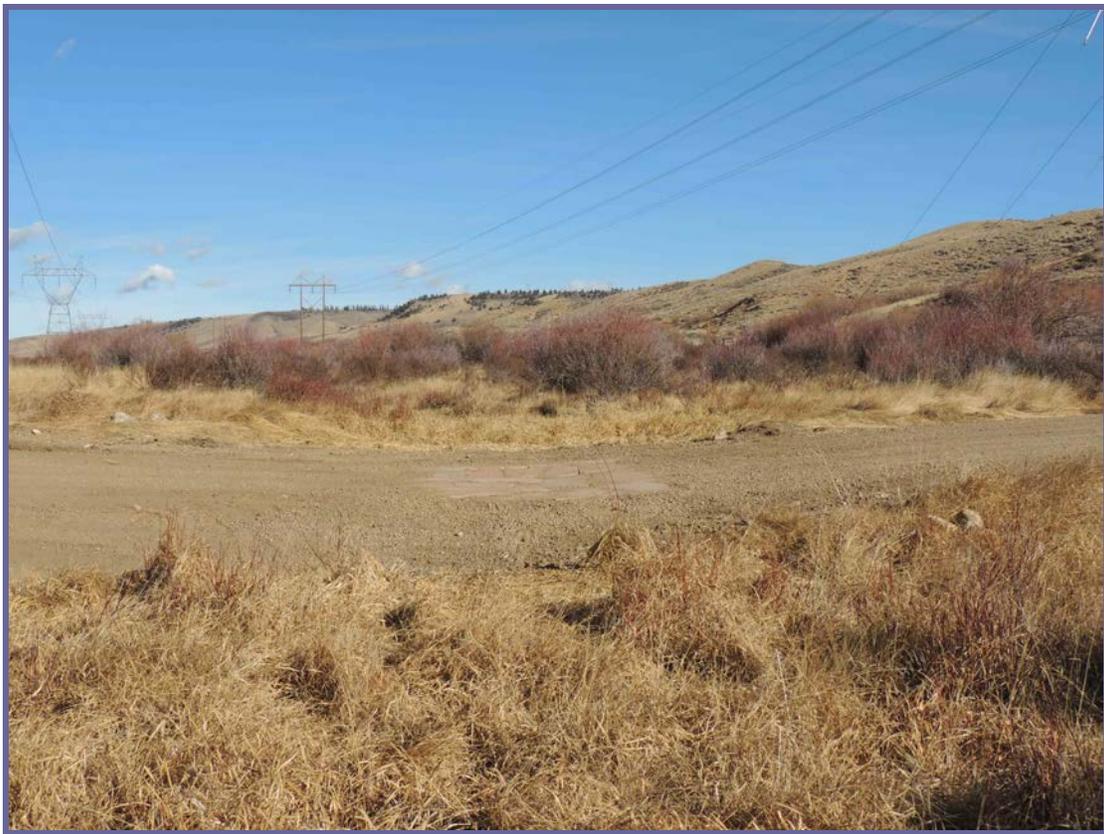
As Built: Station 2+23 following removal of Culvert #6 and replacement with Low Flow Crossing.

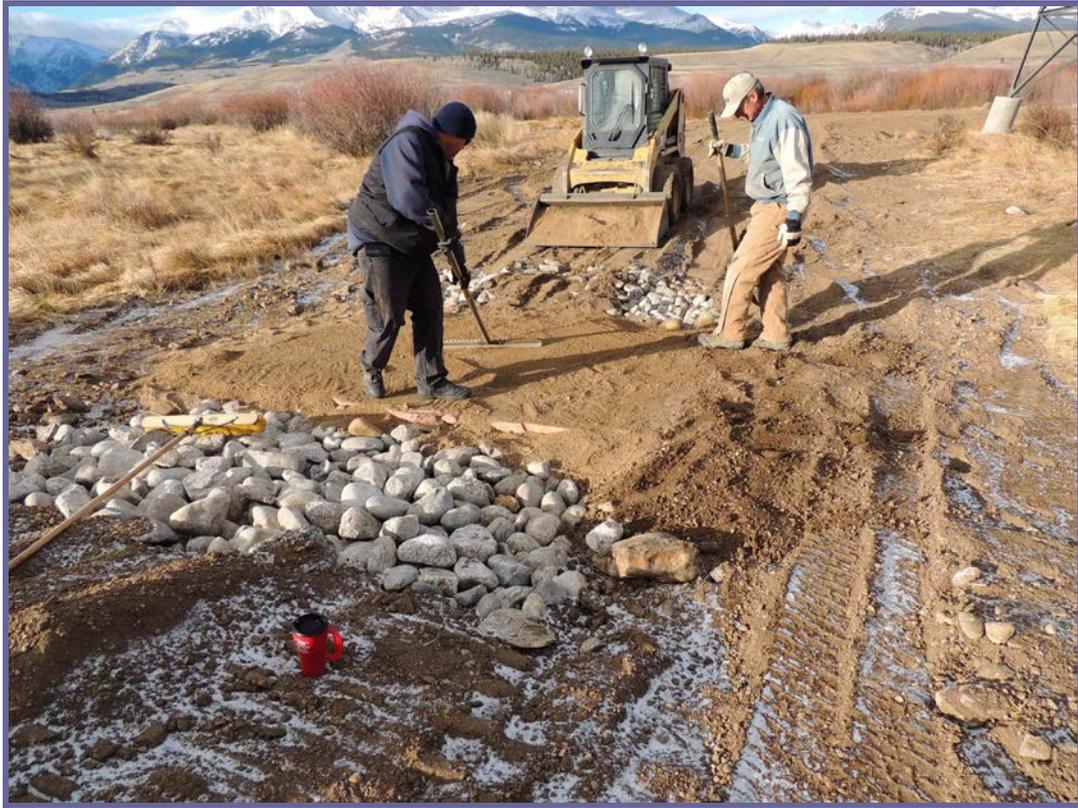
As Built: Station 2+23, construction of Low Flow Crossing.

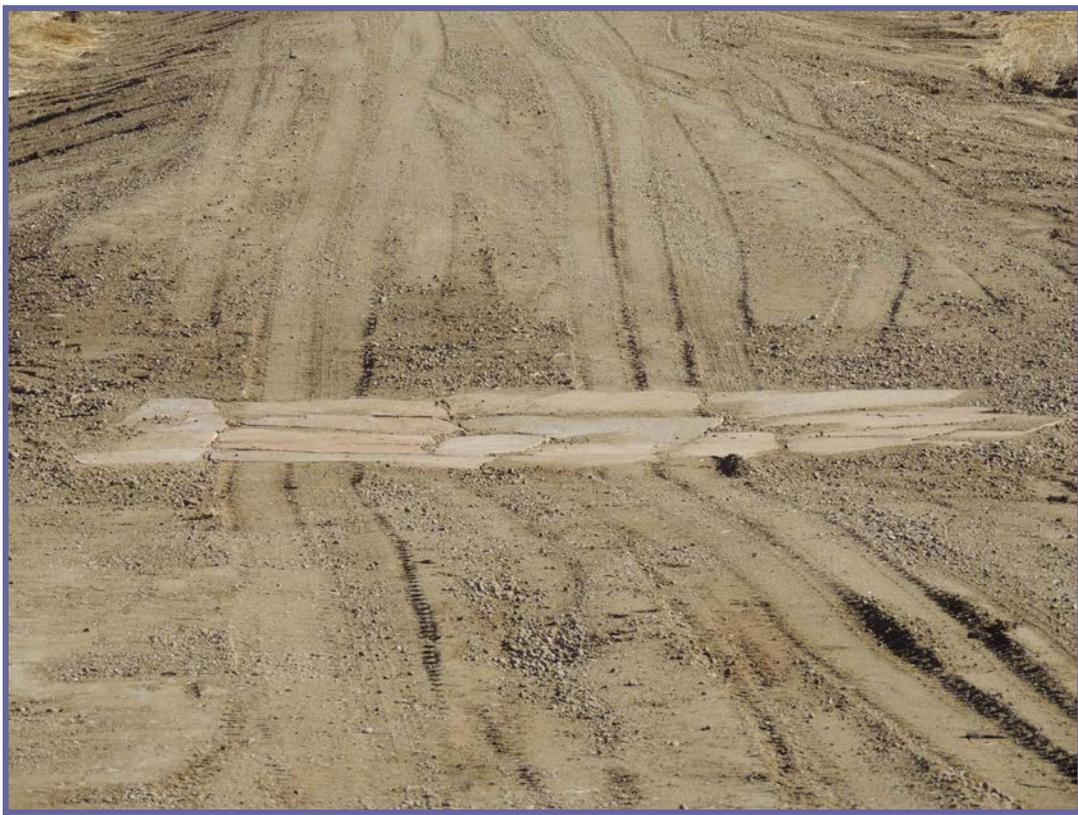
Photo Plate 16

As Built: Low Flow Crossing at Station 2+23.

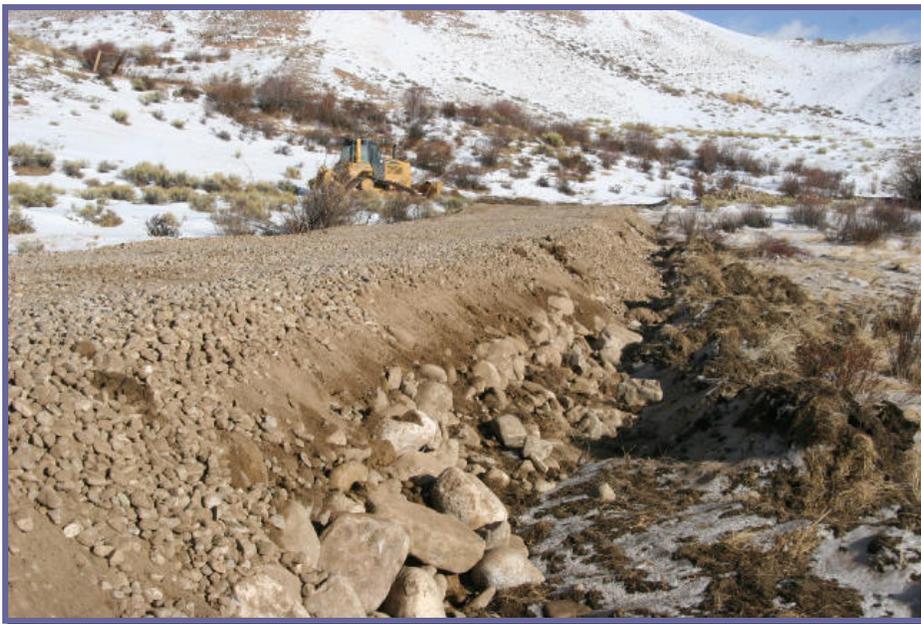
Photo Plate 32

Before: Typical EPA Haul Road Construction: Station 2+00 looking east to Point of Beginning (0+00) during EPA haul road construction. Note: 3 foot thick layer of 6" plus cobble, one foot layer of 3/4" minus fines, and 6 inch layer of 2" minus traction rock to support heavy equipment.

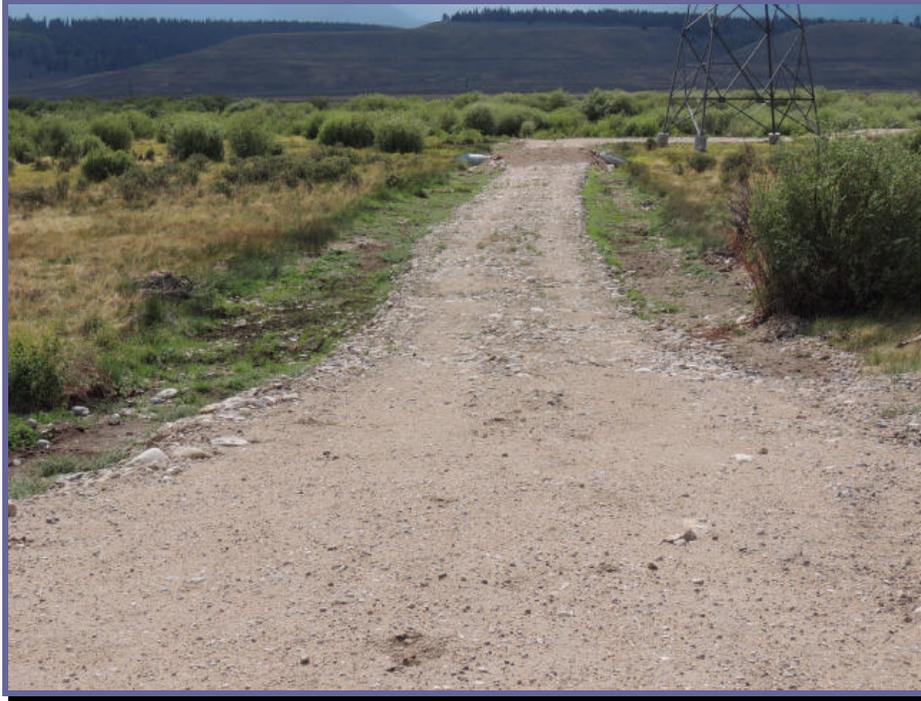
Before: View from Station 0+00 looking west to Culvert 6 (Station 2+23) following EPA reduction in road profile to nominal 1' thick x 10' wide travel surface. Note: Exposed cobble and absence of revegetation on travel surface.

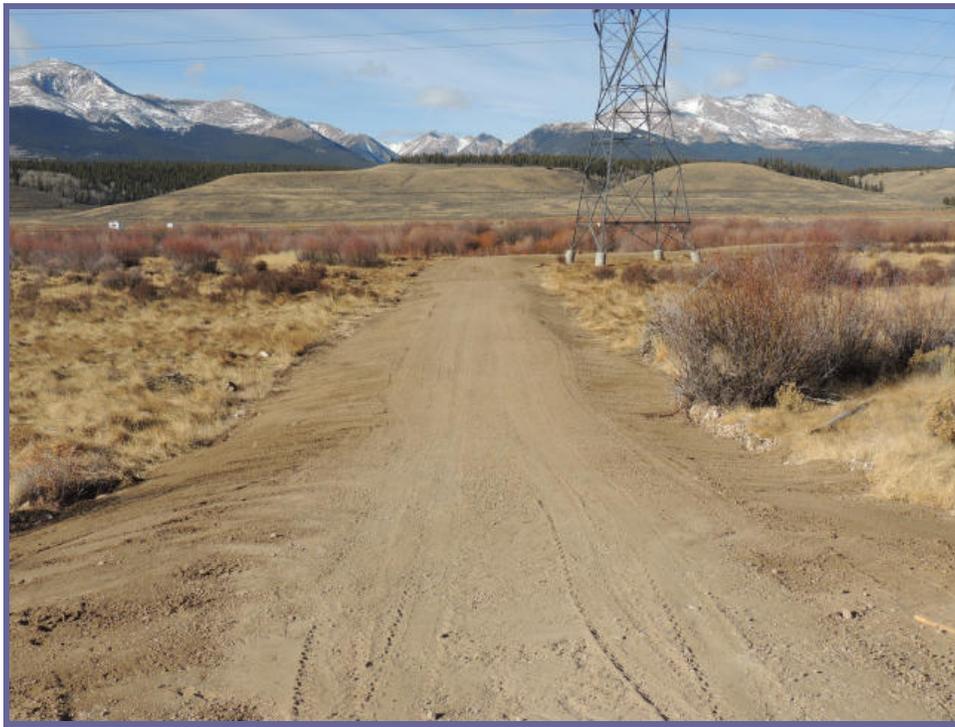
Photo Plate 34

As Built: View from Station 0+00 looking west. Culvert #6 removed and replaced with Low Flow Crossing, edges of road tapered, then covered with 3/4" minus fines to: shed water; facilitate revegetation and wicking of water to root zones; and to blend trail base into surroundings. Target travel width -10', target side slope - 4:1.

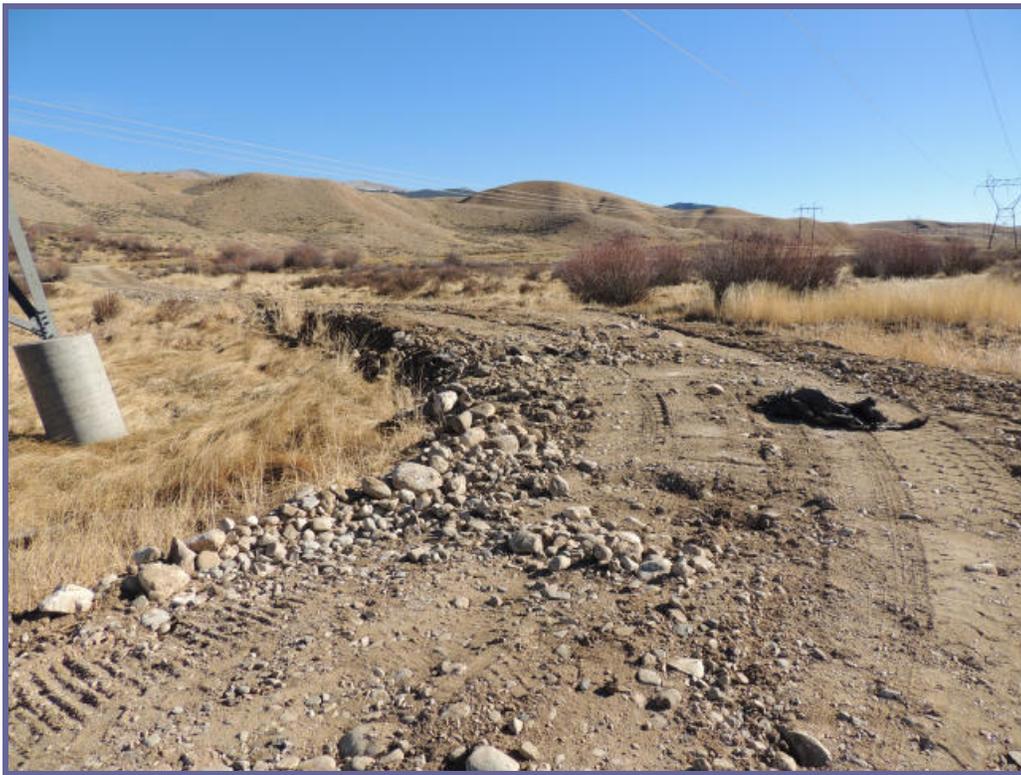
Before: EPA Haul Road at Station 4+00 looking south: following EPA lowering of profile but before re-grading and addition of growing medium.

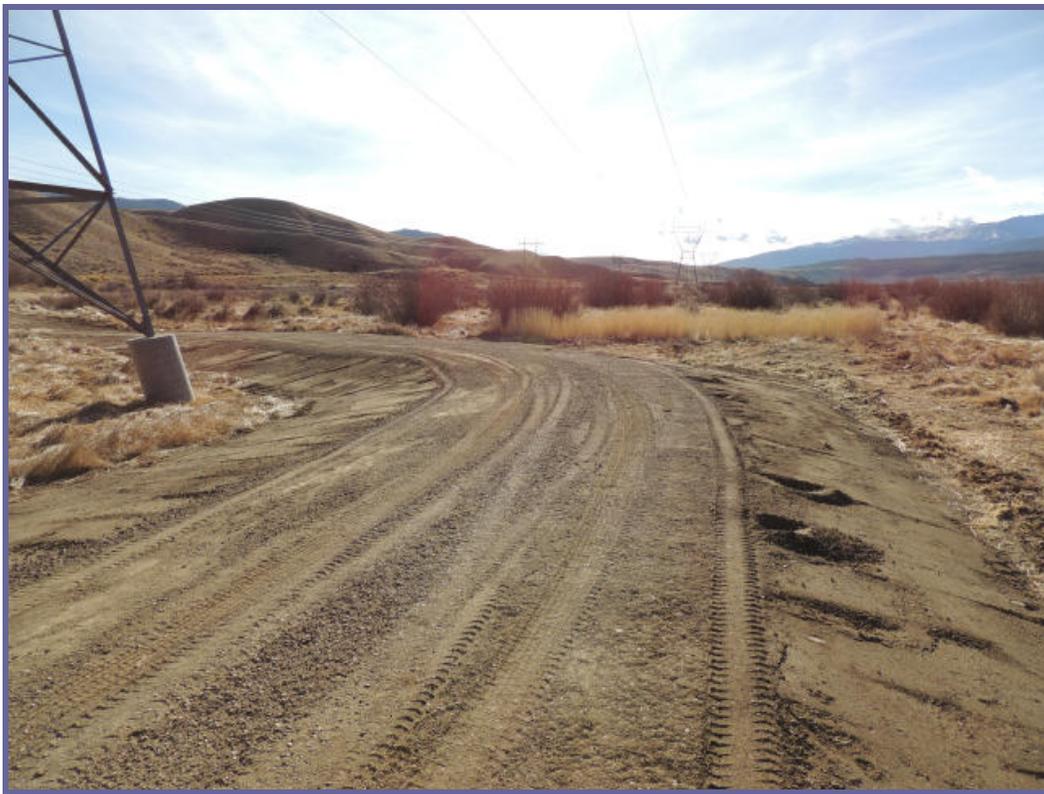
Photo Plate 36

As Built: Station 4+00 looking south: following EPA lowering of the road profile, re-grading, and addition of growing medium. 10' wide travel surface tapered to surrounding topography to provide a growing medium and reduce visual impact.

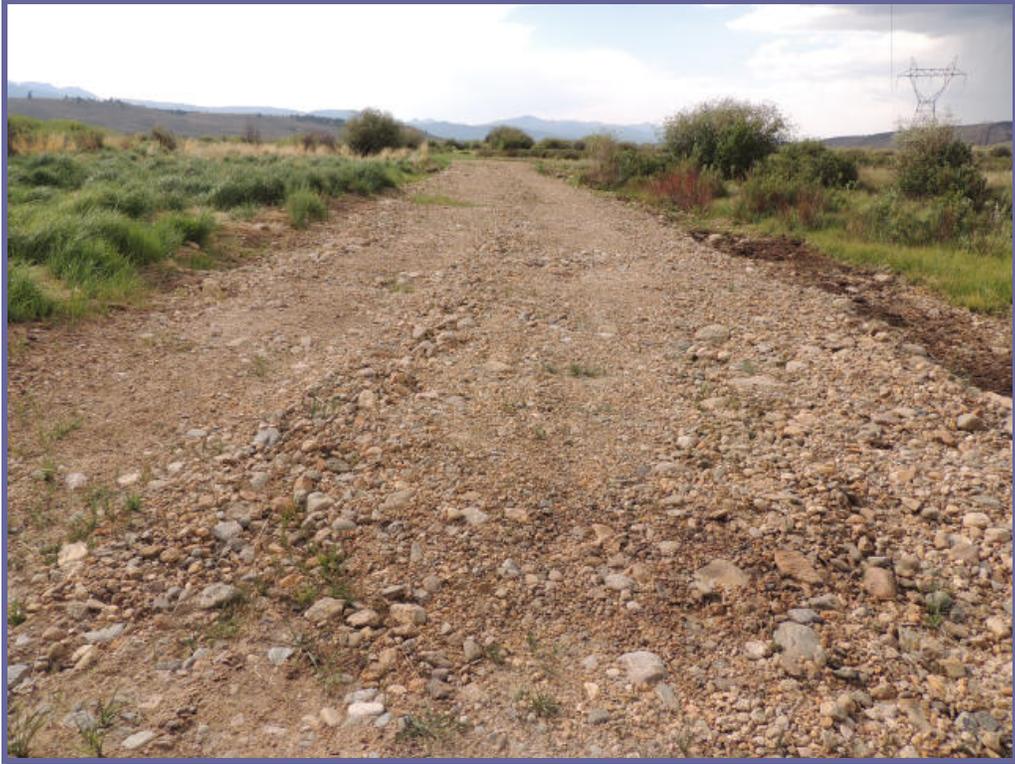
Before: Station 4+50 looking north before regrading and addition of growing medium. Note: exposed cobble and lack of revegetation on travel surface.

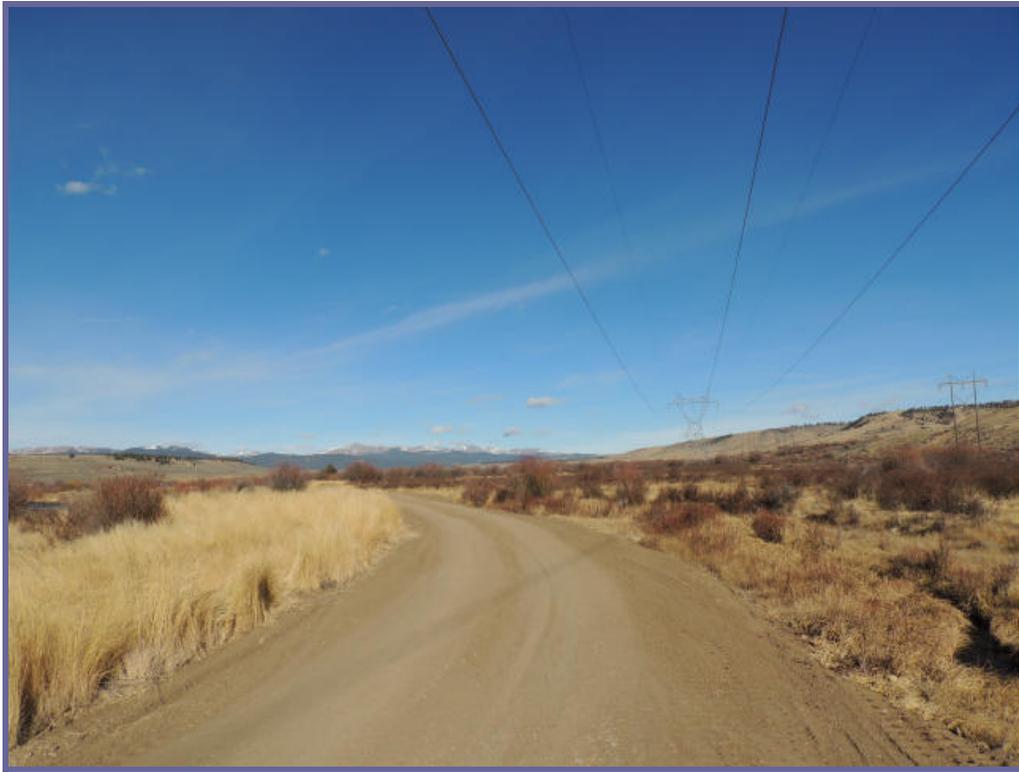
Photo Plate 38

As Built: Station 4+50 looking north following re-grading, addition of growing medium, and blending edges to surrounding topography. 10' travel surface with 4:1 side slopes.

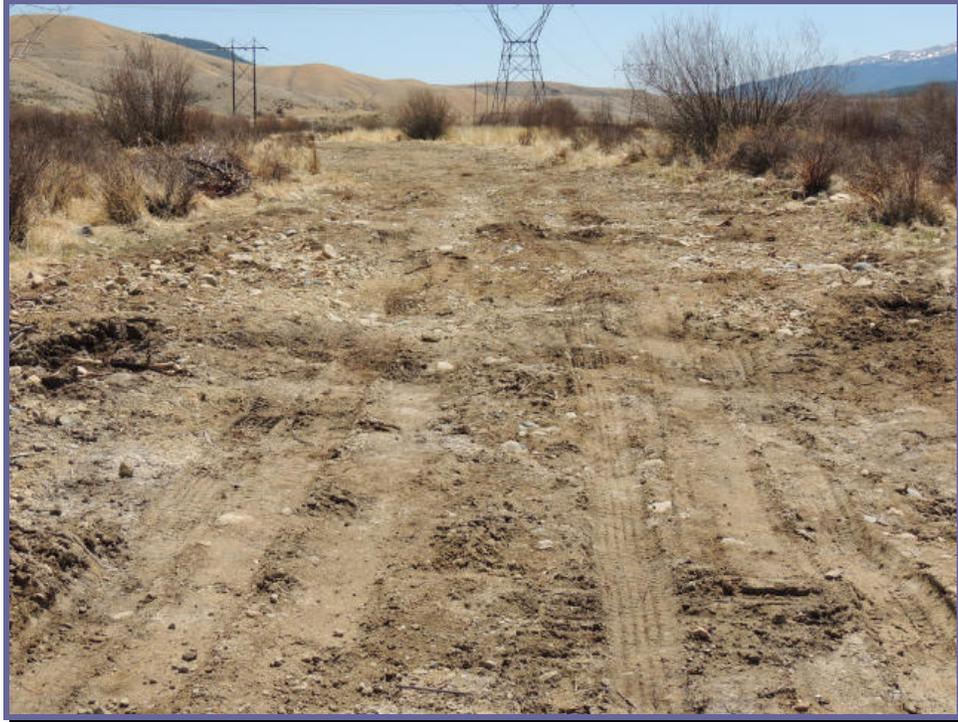
Before: Station 10+50 looking south, rough travel surface resulting from winter removal of frozen materials during EPA lowering of haul road profile.

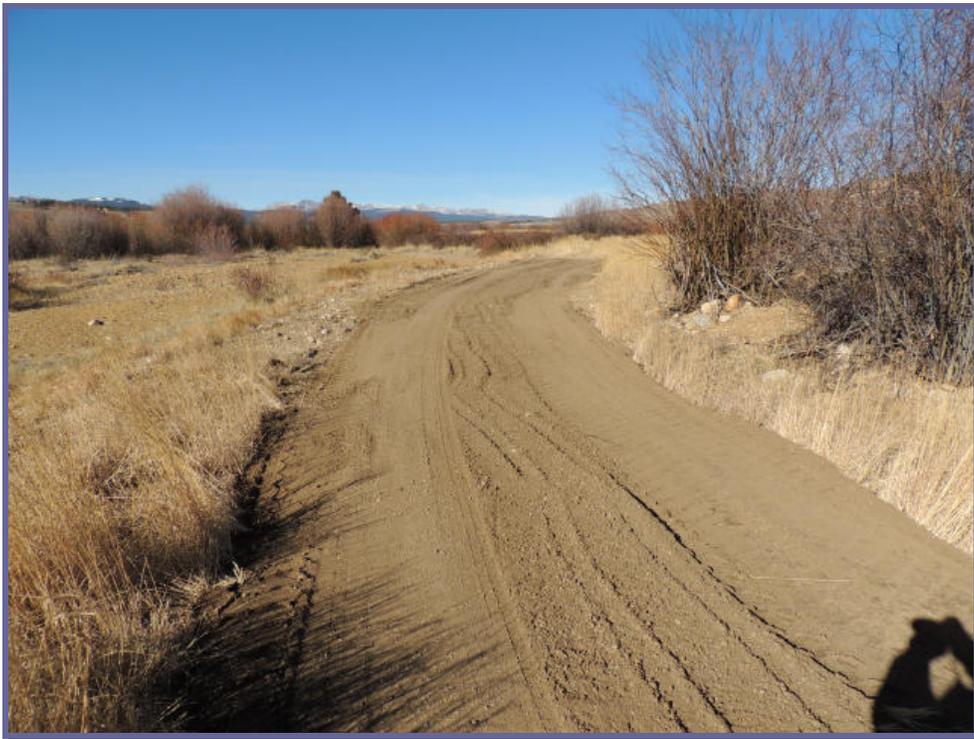
Photo Plate 40

As Built: Station 10+50 looking north following re-grading and addition of $\frac{3}{4}$ " minus material. Note: only enough $\frac{3}{4}$ " minus material added to smooth travel surface and blend growing medium to surrounding ground.

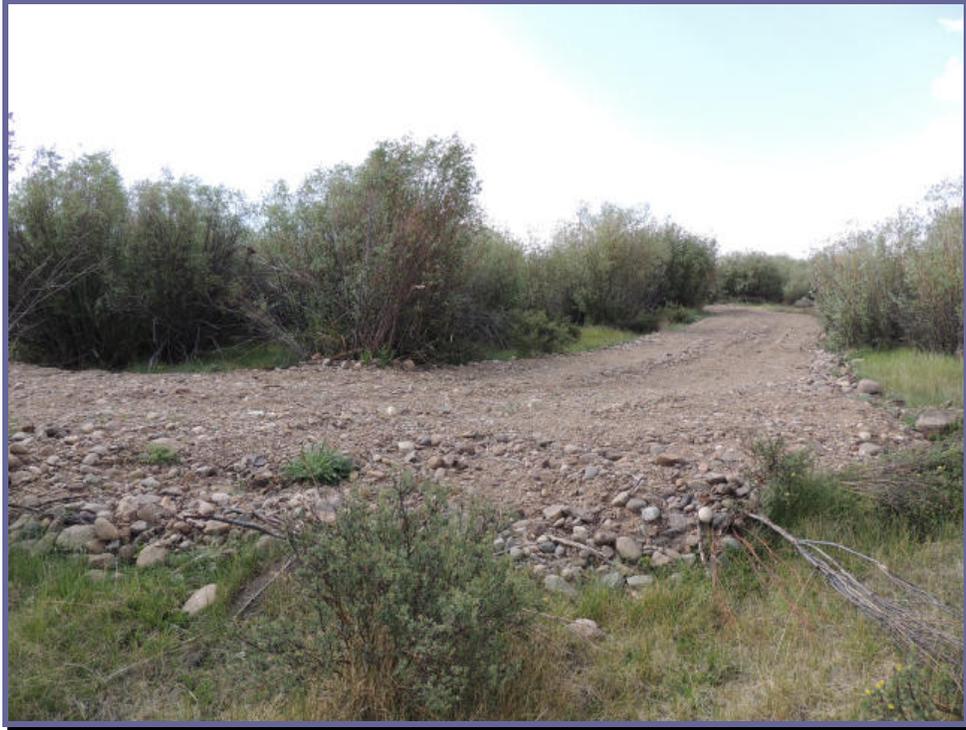
Before: Curve at approx. Station 18+50 looking north. Bypass around Area of Avoidance 2: “Stream bank failure”, prior to re-grading and addition of growing medium. Note: exposed cobble and lack of vegetation.

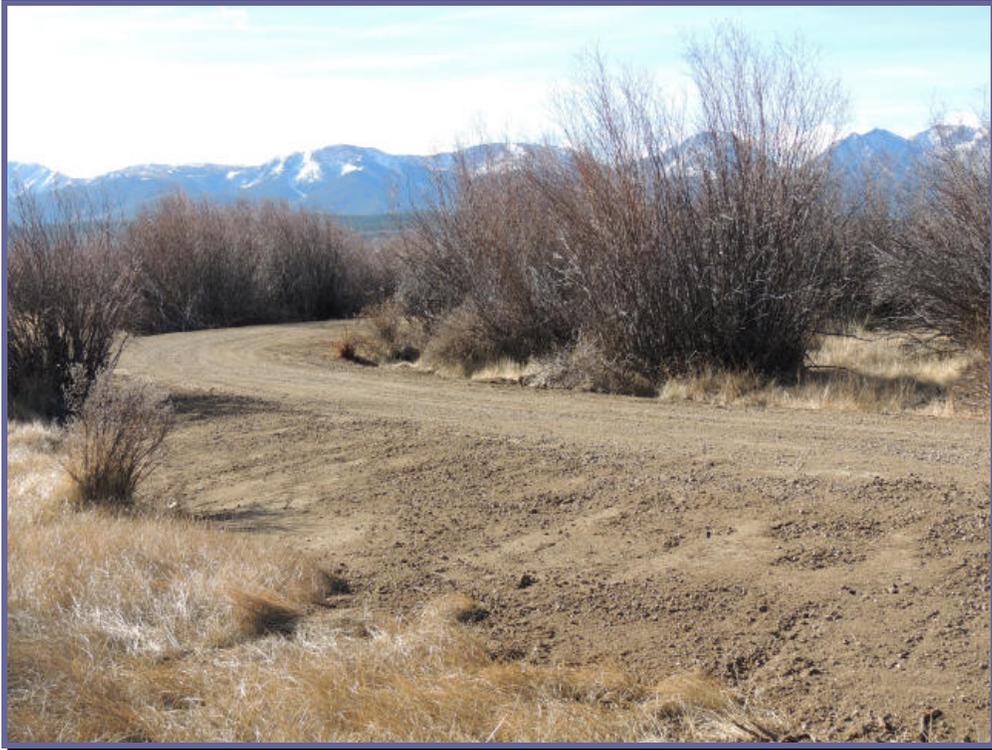
Photo Plate 42

As Built: Same curve at approx. Station 18+50 looking south. Bypass around Area of Avoidance 2: “Stream bank failure”, following re- grading, addition of growing medium, and blending the edge at a 4:1 slope to surrounding topography.
