Arkansas River Ranch Trail Phase I Construction Layout As Built Photo Plates and Figures

**Prepared for:
Arkansas Headwaters Recreation Area
Colorado Parks and Wildlife
307 W. Sackett Ave.
Salida, Colorado
81201**

December, 2012

**Arkansas River Ranch Trail
Phase I Construction Layout
As-Built Illustrations**

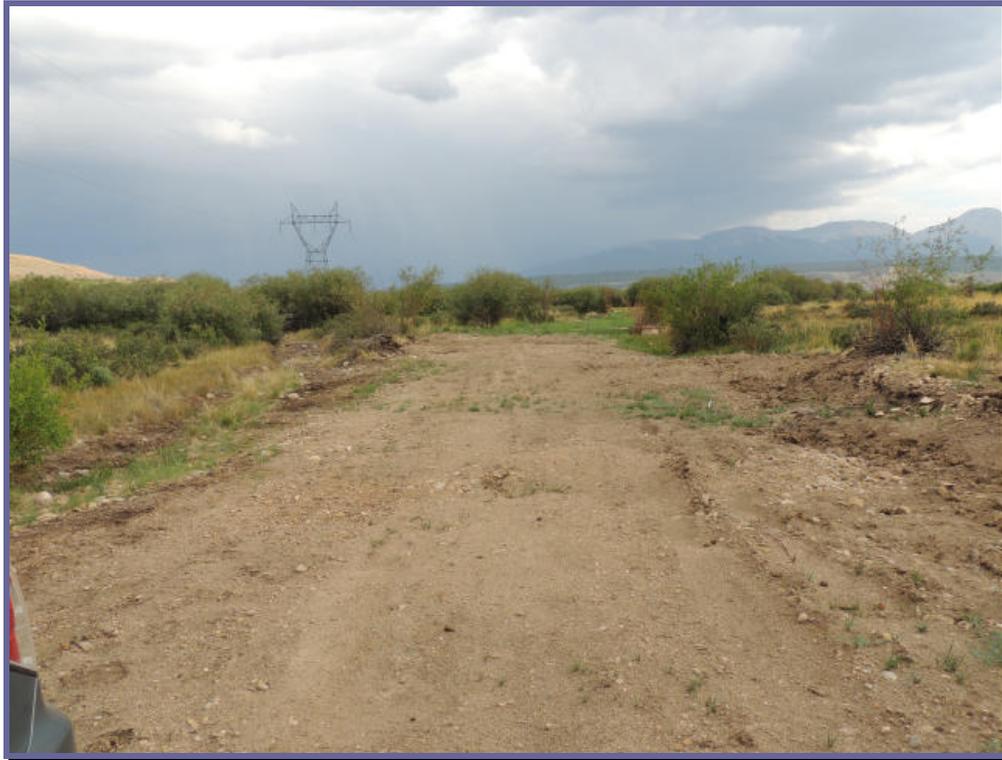
Before: Station 23+50 looking south showing lower part of the cut bank on west side of travel surface left by winter removal of surplus road material.

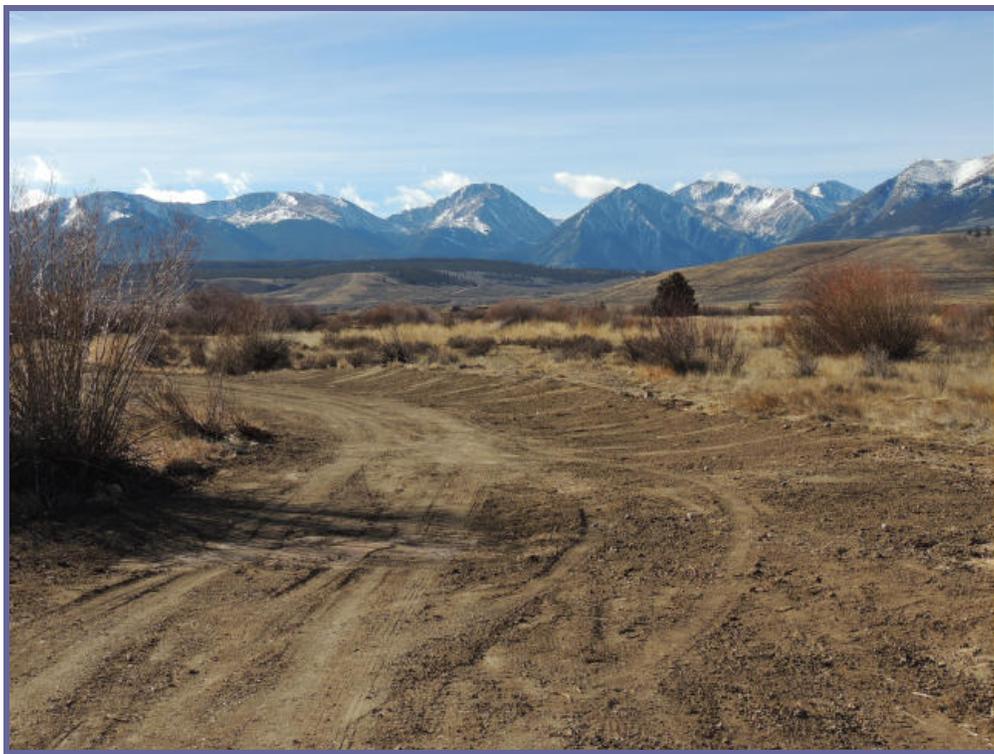
Photo Plate 44

As Built: Station 23+70 looking south at same cut bank following re-grading and addition of fines.
